Visual Property Inspection

123 Anystreet
Pennington, New Jersey 08534

Report Commentary

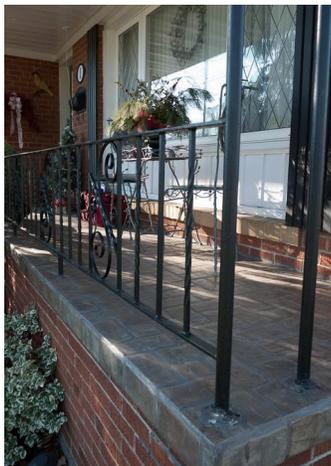
Front Porch Light

Exercise caution. Front porch rail is a potential safety hazard due to height and detailing.

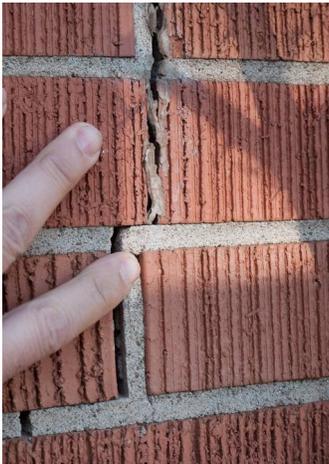
Settlement cracks identified at west wall of garage. This crack should be sealed to exclude moisture and insects. Monitor over time to identify if it continues to settle and correct if necessary.

Settlement crack at west wall of garage

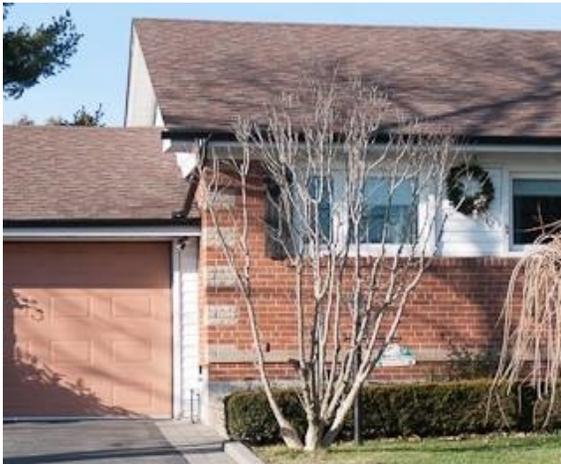
Caution: The entire front gutter system drains ultimately to a single downspout. This is a lot of water for a single downspout. The gutters may overflow during a storm. Consider adding additional downspouts.

Caution: the planter box at the front of the house projects past the drip/overflow line of the front gutters. If the front gutters were to overflow during a storm, the planter box could cause basement flooding. Maintain gutters clear of leaves and debris.

Shows upper gutter draining into lower gutter

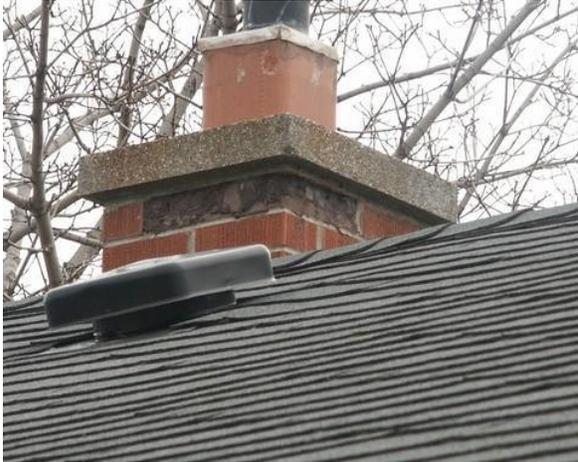
Minor brick damage

Repair minor brick damage.

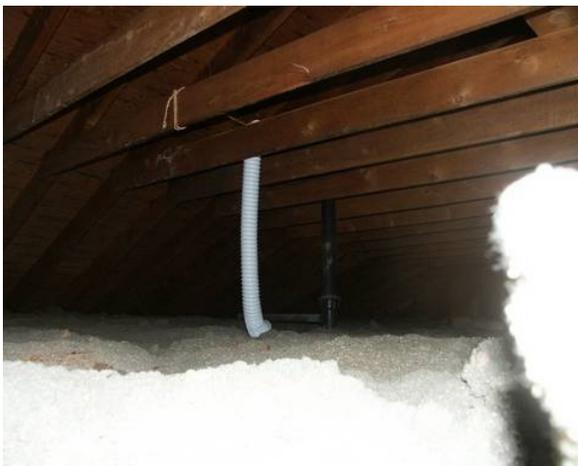
Bathroom exhaust - venting into attic

Extend exhaust vent to discharge to the exterior to reduce moisture/condensation related damage.

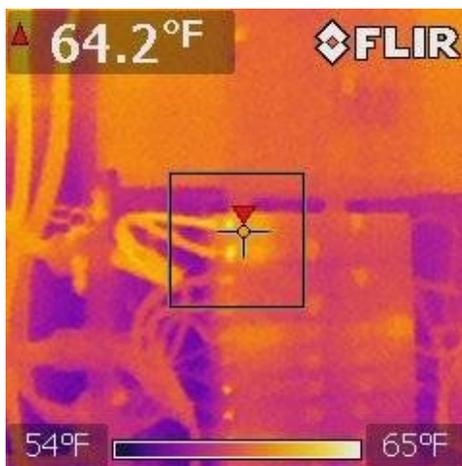
The electrical distribution panel was scanned with an infrared camera per the Pillar To Post Standards of Practice for infrared scanning. All circuits in the panel were found to be operating within designed temperature limits.

IR shot of breaker panel showing normal temperatures

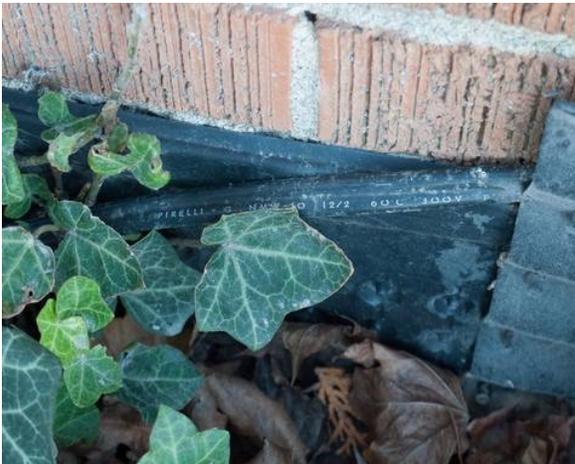
Exposed electrical cable in east side garden is dangerous and should be corrected by an electrician.

Exposed electrical cable at east side of home in garden

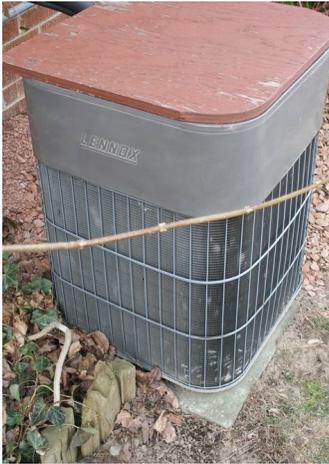
AC system is well passed its intended life cycle. While it is still functioning as intended, consider replacing this system pro-actively at the same time as the furnace to ensure a compatible system that will fit in the current space in the furnace / utility cupboard. A new system will be significantly more efficient as well.

A/C condenser at east side of home
