Visual Property Inspection

123 Anystreet
Pennington, New Jersey 08534

Report Commentary

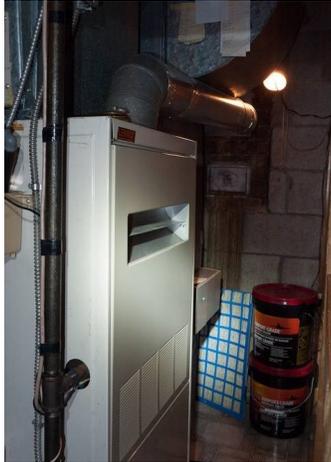
Heating / Cooling

The heating system was inspected and operated. It is functional at this time, however, the system has exceeded typical life expectancy. As we discussed, the residual life is unpredictable. Consider replacing the system pro-actively to avoid the increased cost of replacing the system in cold weather.
